Test report  
8016F2023

## SALT SPRAY TEST (Neutral Salt Spray Chamber)

Sample description: n.8015F2023 – IRONLEV SLIDER WD SLIM

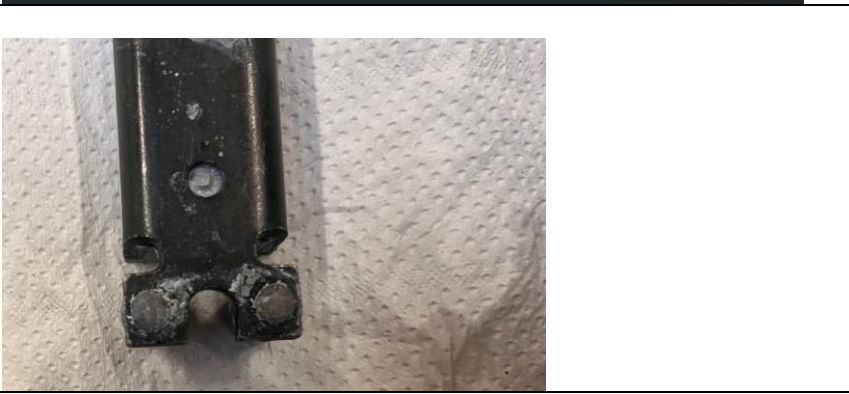
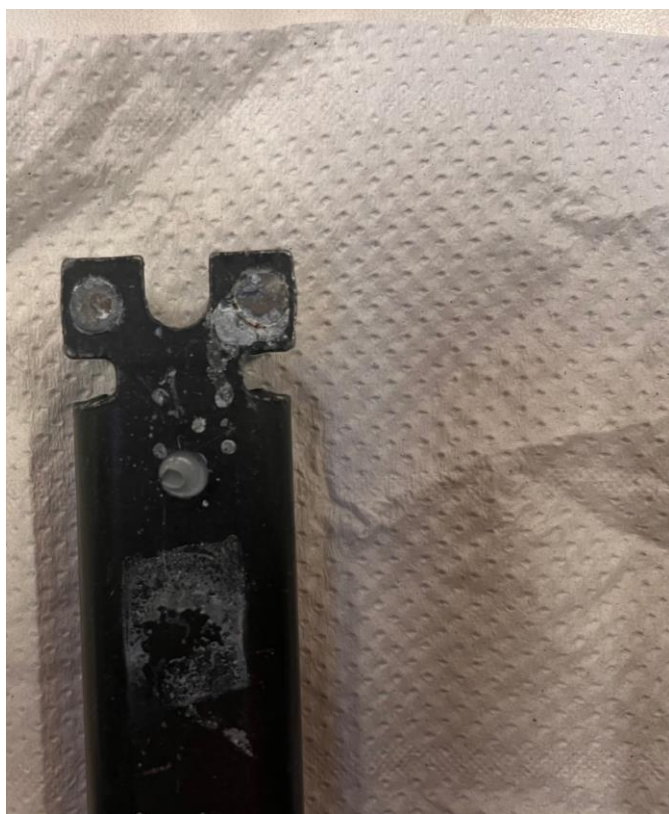
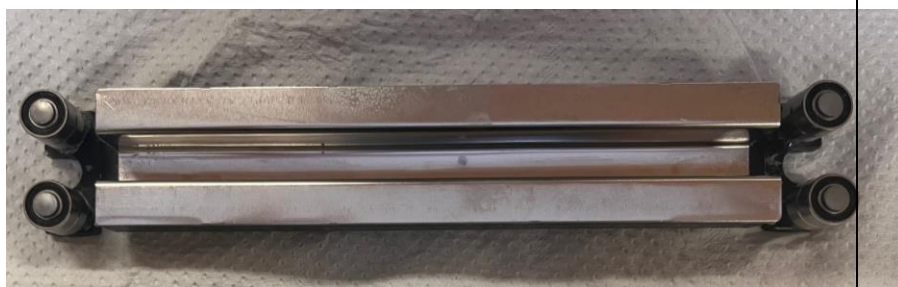
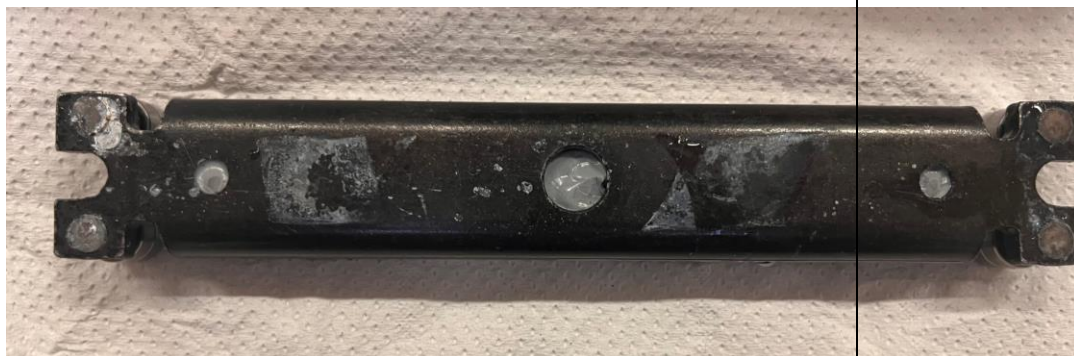
| | <p>500 h</p> |

| SAMPLE | DESCRIPTION | note | RESULT AT 1000 H |
|---|---|---|---|
| 8016F2023 | IRONLEV SLIDER WD SLIM | <p>After 500 hours appeared first pits (rust) between the seat of the shoe and the rivet fixing wheel.</p> <p>At the end of the 100 the area affected by rust has increased but is still less than 0.1% of the total area of the specimen.</p> <p>at the magnets there are no corrosive phenomena</p> | Rp =9 |
